Investigation of stability of ITER candidate Hall sensors under neutron irradiation

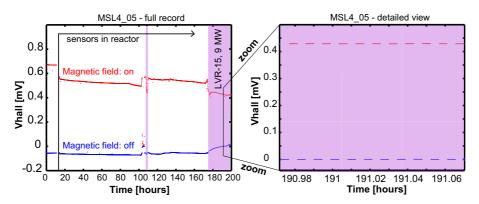
seconds/sample. The calibration magnetic field was periodically turned on and off with a pattern: 10s ON, 10s OFF to eliminate large temperature changes due to Joule heating from the calibration coil. The calibration magnetic field was measured with a sampling rate of 4 seconds/sample. The data record from sensor MSL4_05 is shown in the left panel of Fig. 2. Data plotted by red colour are taken during the time intervals when the calibration magnetic field was switched ON, while the blue denotes that there was no magnetic field during measurement. Detailed view of the several measuring cycles is shown in the right panel of Fig. 2. Unfortunately, due

Fig. 2. Record of the MSL4_05 output voltage monitored during the irradiation campaign (left panel). Detailed view zoomed around 191 hour (right panel). Time interval when the reactor was running at 9 MW is denoted by purple colour.

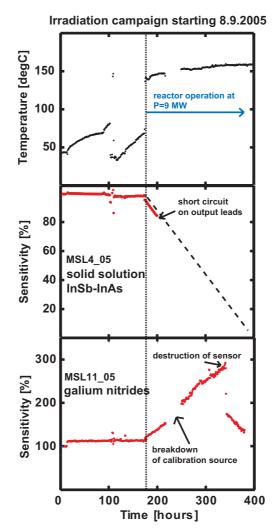
sors sensitivities due to temperature variations. The best results, in terms of lowest change of sensors output before the activation of reactor were obtained using coefficients of temperature dependence of sensor sensitivity 0.18 %/K in case of MSL4_05 and 0.1 %/K in case of MSL11_05. The resulting temporal evolutions of sensors sensitivities during irradiation are plotted in Fig. 3. The top panel shows irradiation

Fig. 3. Top panel – temperature of the irradiation head. Middle panel – temporal evolution of sensitivity of MSL4_05. Projected evolution after hour 200 (short circuit of output leads on irradiation head structure) is plotted by dashed line. Bottom panel – temporal evolution of sensitivity of MSL11_05 sensor.

head temperature evolution during irradiation. The start of reactor operation is denoted by solid line. The evaluated sensitivities of MSL4_05 and MSL11_05 are

plotted in middle and bottom panels. The sensor MSL4_05 accumulated total neutron fluence of $6.7 \times 10^{16} \text{ n/cm}^2$ (with a fraction of $4.6 \times 10^{16} \text{ n/cm}^2$ of fast neutrons 0.1 MeV \div 20 MeV). At this fluence, which is about one fourth of the target ITER life time fluence ($2.5 \times 10^{17} \text{ n/cm}^2$), the sensitivity of MSL4_05 decayed by a little less than 20%. Unfortunately, at this point, the short circuiting of MSL4_05 output leads occurred that disabled further monitoring also of this sensor. The sensitivity of MSL11_05 was followed up to 'destruction' at $2.7 \times 10^{17} \text{ n/cm}^2$ (with a fraction of $1.9 \times 10^{17} \text{ n/cm}^2$ of fast neutrons), which is slightly above the target ITER life time fluence. The sensitivity of the sensor reached almost 300% of pre-irradiation value at that point. Significant noise level and large offset voltage are drawbacks of this sensor up to now.
